# Technical Memorandum

January 31, 2025

<b>To</b>	Roland Yip, PE, City of Pacifica	<b>Contact No.</b>	925 849 1019
<b>Copy to</b>	--	<b>Email</b>	satish.chilka@ghd.com
<b>From</b>	Satish Chilka, PE Madeline Mueller, EIT	<b>Project No.</b>	12599413
<b>Project Name</b>	Pacifica Pier Condition Assessment		
<b>Subject</b>	Post Storm Condition Assessment –January 2025

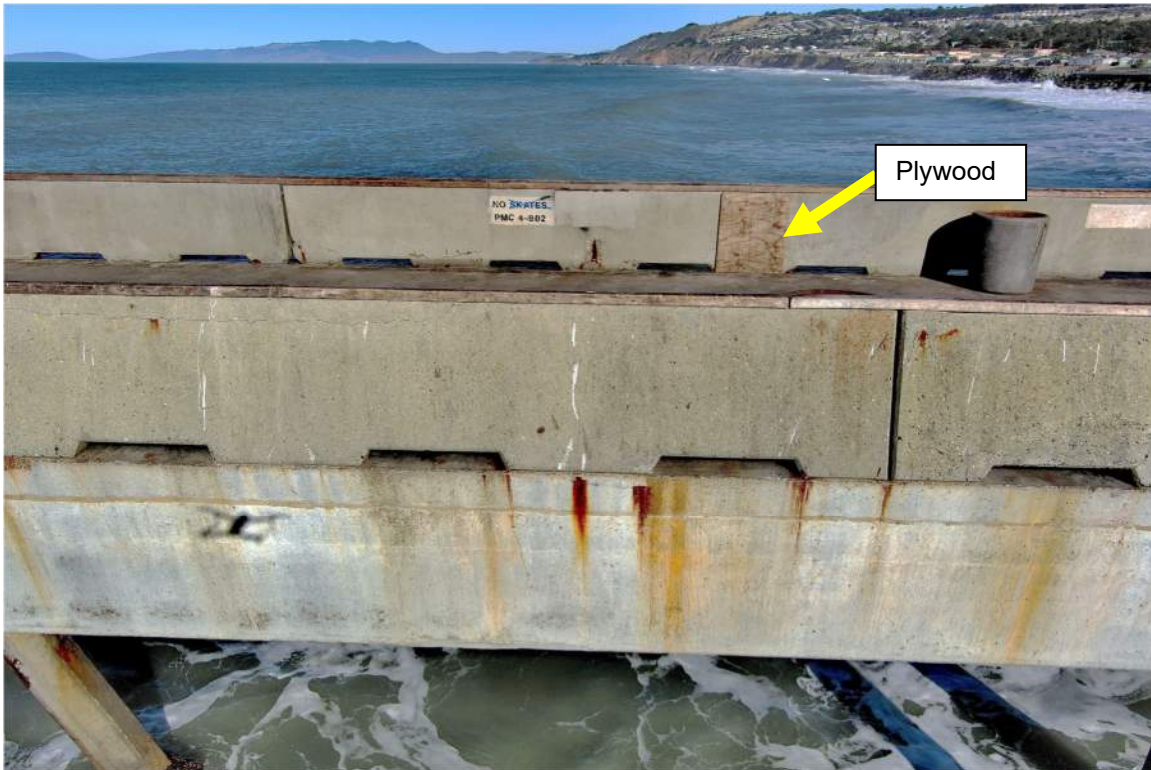
Figure 3.1 Plywood over spalling damage on handrail.

Several of the large open gaps between handrails along the portion of the Pier open for public access are covered by plywood after the 2024 assessment (Figure 3.1). Damage was also noted at several of the pile bent caps with large cracks, staining from corrosion, and spalling concrete (Figure 3.2 and Figure 3.3). The spalling at Bent R, also noted in 2024, has worsened, but since the damage was already rated as Severe, the rating does not change (Figure 3.4 and Figure 3.5).

The large gaps in the handrails should be boarded with plywood or other means to reduce risk of injury from exposed reinforcement and rough concrete surfaces.

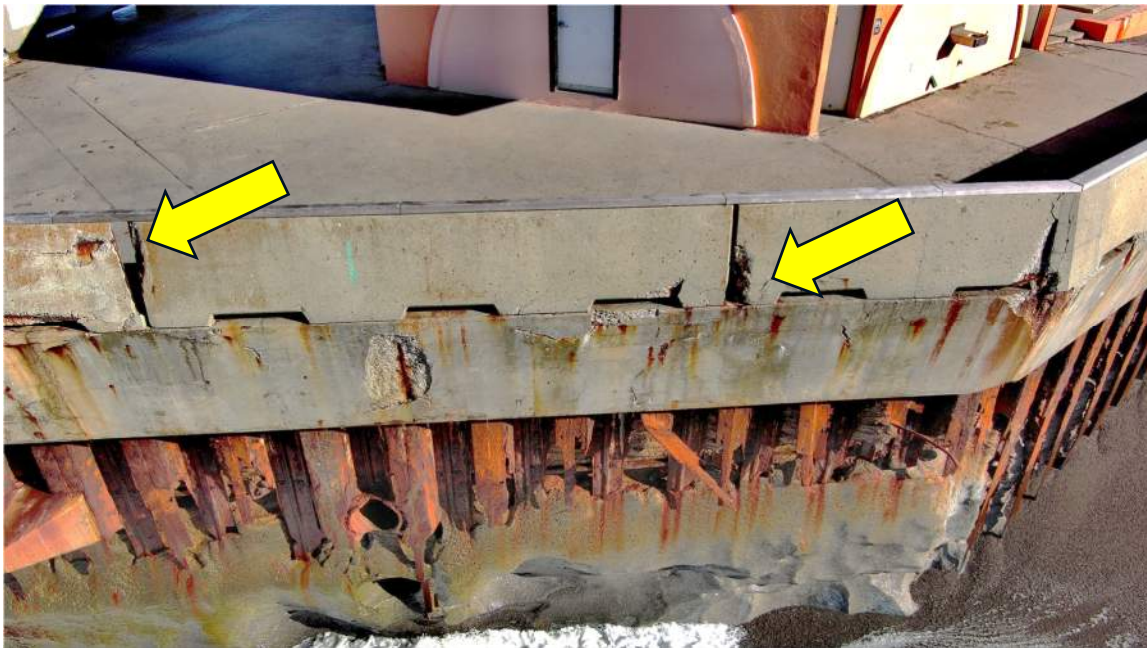
**Figure 3.6** Large Gaps between Handrail near Gate on South side of Pier

A few large uncovered openings were noted along the handrails as shown in Figure 3.6. These openings have resulted from loss of previously spalled concrete. These damages do not impact the functionality of the handrails but the open spill, exposed reinforcement and size of the openings greater than 4-inches pose a hazardous condition.

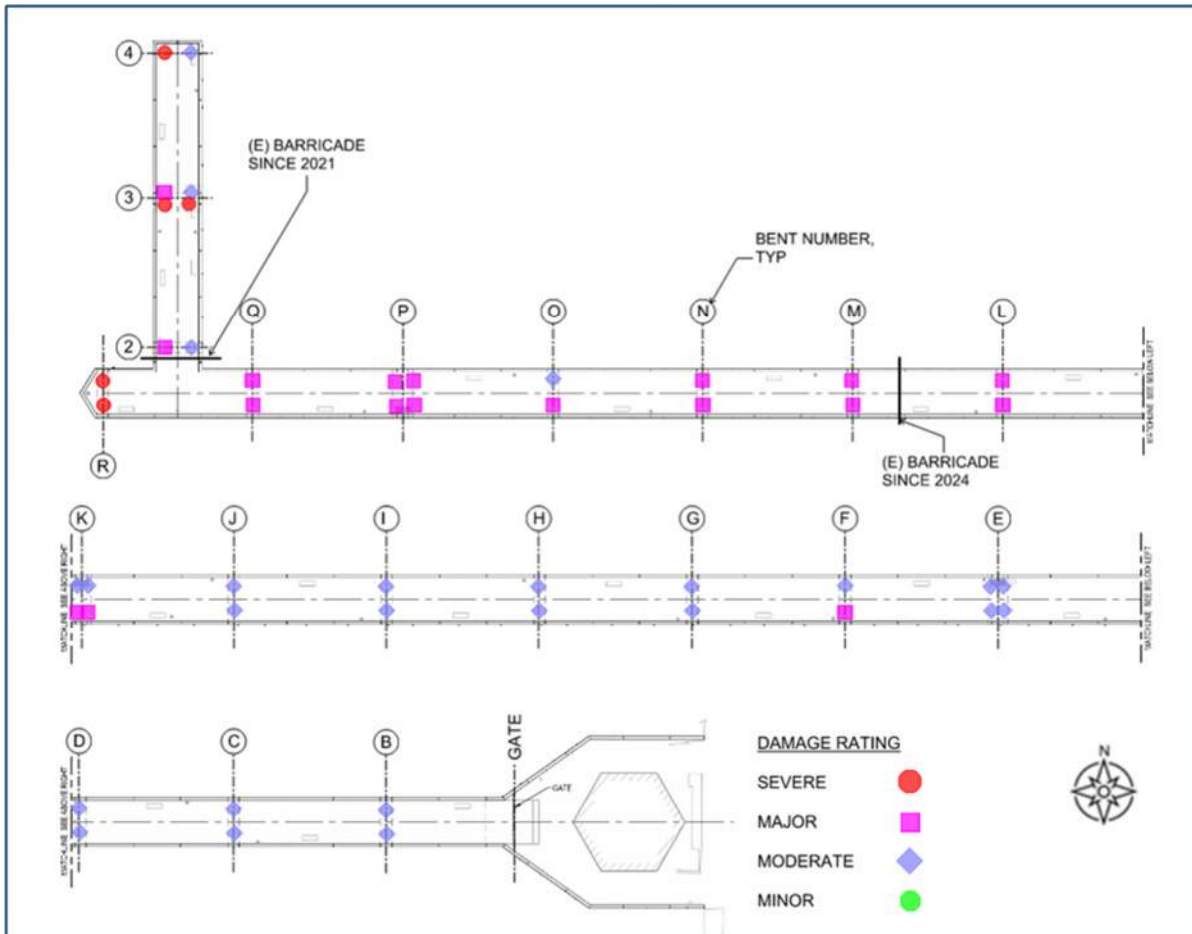
Figure 3.7 Damage Rating- Piles, Above Water Observations 2025.

Between the storm assessment in 2024 and in 2025 the damage rating on one pile at Bent P changed from moderate to major. At the pier extension and Bent R several of the piles rated severe have additional spalling since the 2024 storm assessment. A summary of the pile damage ratings is shown in Figure 3.7 for 2025.

The offshore end of the Main Pier and the Pier Extension are exposed to most severe impacts from the storm events. The damaged piles along Bent R, Bent 3 and Bent 4 are recommended for repairs in the near term. The open spalls on these piles have increased in size and exposed more of the underlying corroded reinforcement. Although the piles and deck are not subject to heavy loads during non-storm season, these conditions will worsen over time and pose a significant risk to the stability of the structure. Spalling has increased just over the course of two storm seasons.
