Beach Boulevard Seawall

City Council Meeting
February 8, 2016

Beach Boulevard Sea Wall Emergency Repair

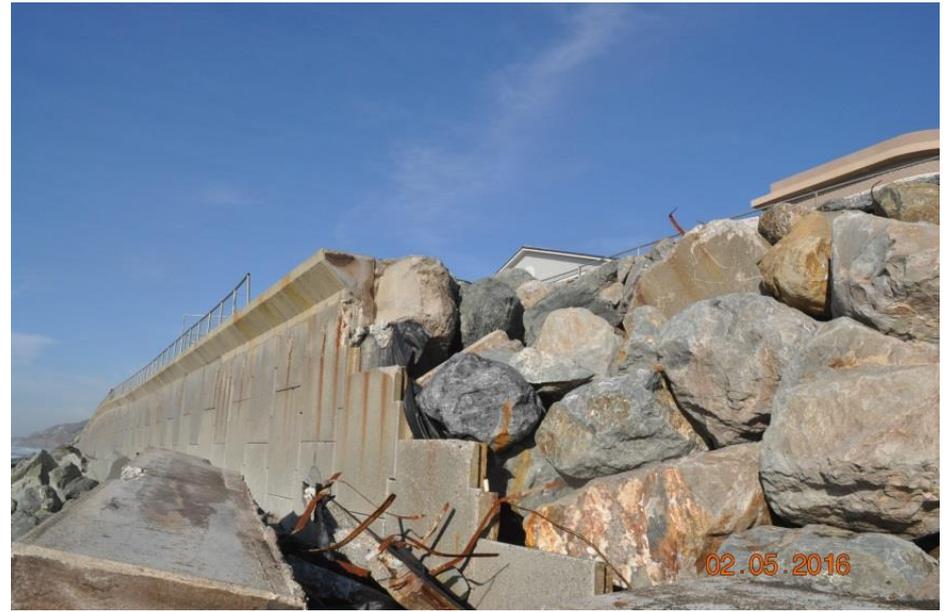
Photo of failed section shows detail of wave deflector, PVC peg and tie back strips

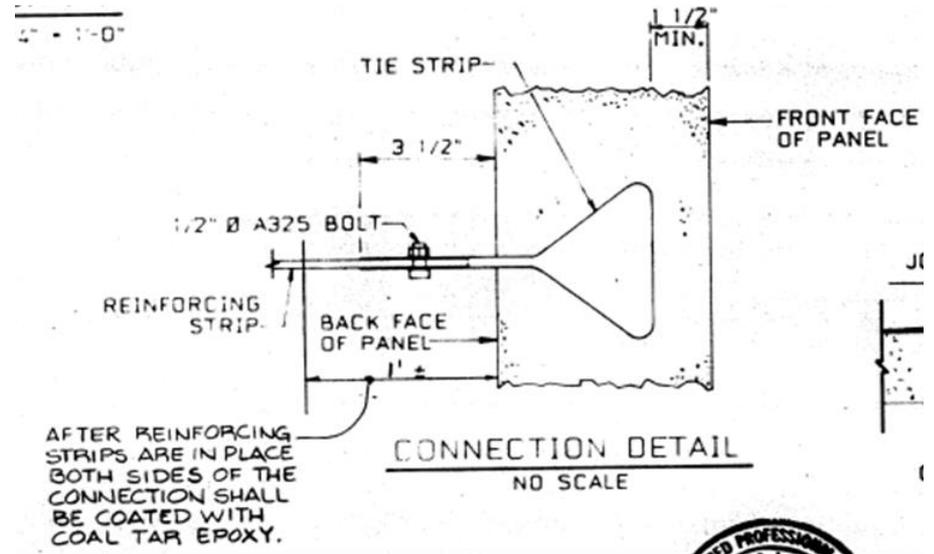
Detail of how 2 in. wide tie back strips are embedded in each tile.

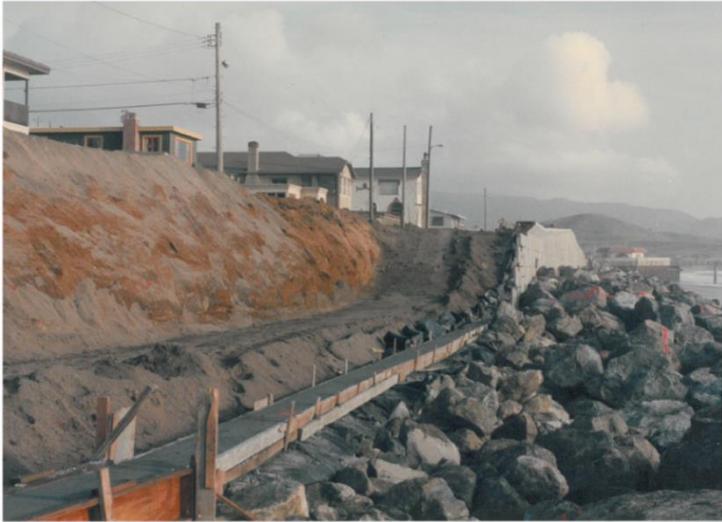
12" x 6" leveling course

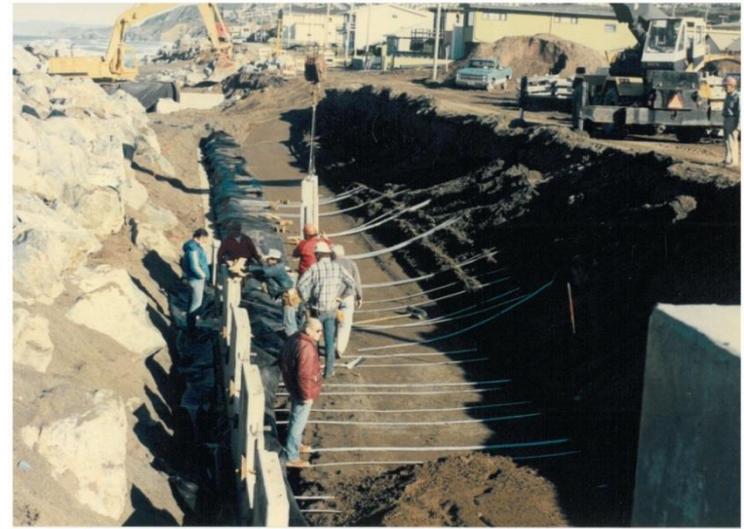
Tie back strips

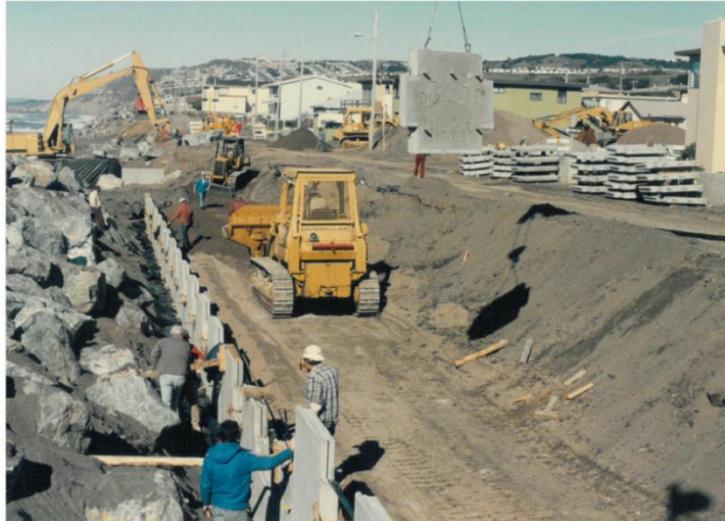
Tile placement

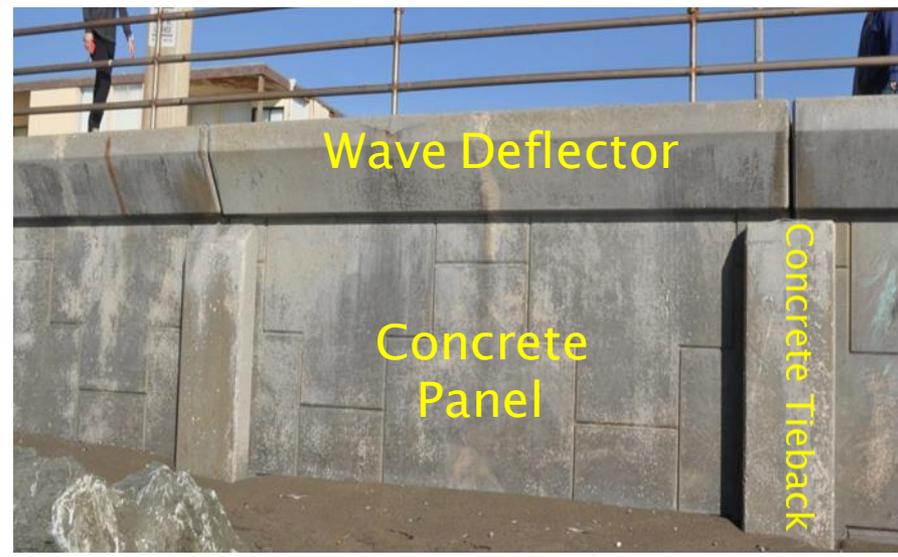
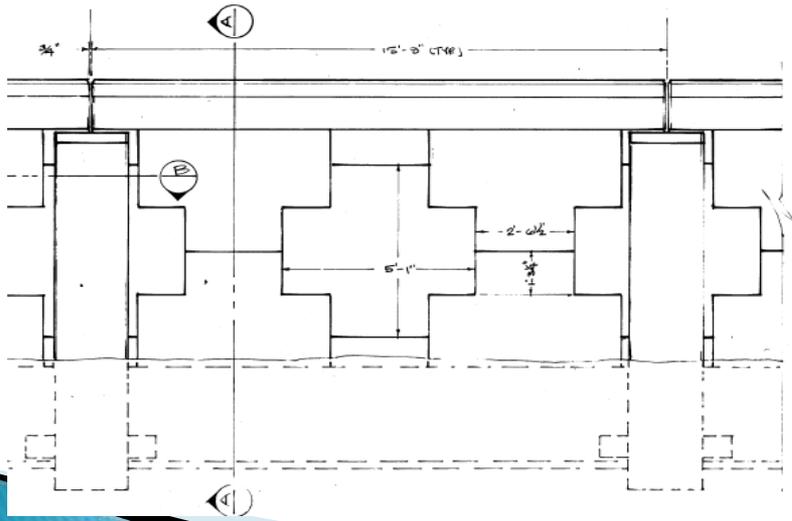
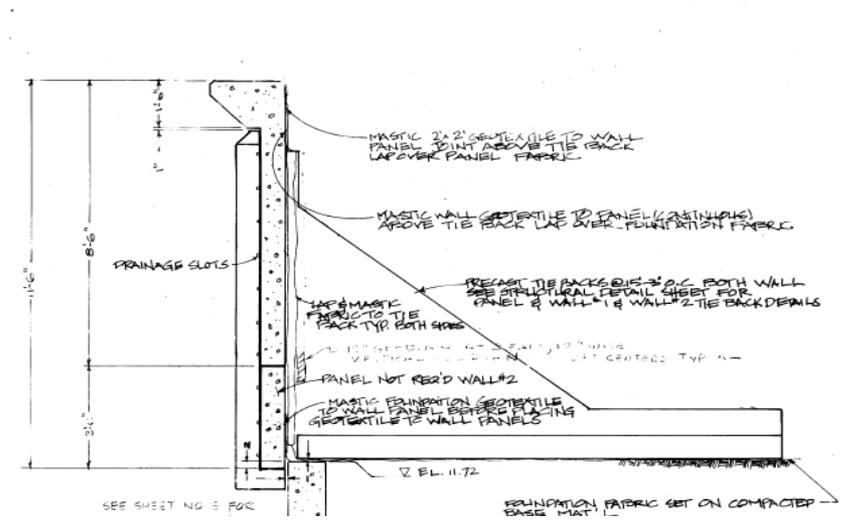
Panel Construction Details

Constructed using solid precast concrete panels approximately 15' wide by 8' high by 8" thick. The panels are supported by a 12" wide by 5'-7' high concrete foundation and are held in place by concrete tie backs. Grooves are added to aesthetically match Phase 1 tile construction

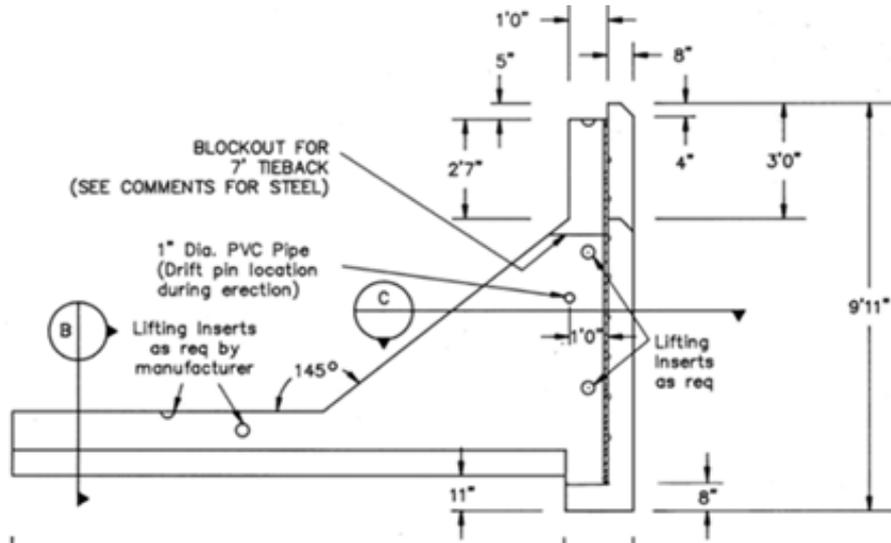
Concrete Tie back Detail

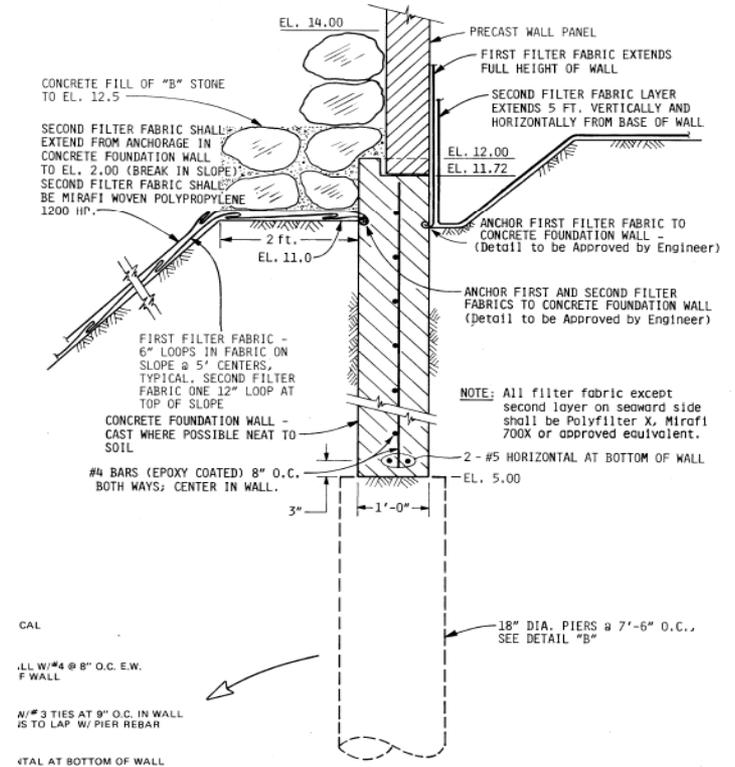
Concrete Foundation Detail

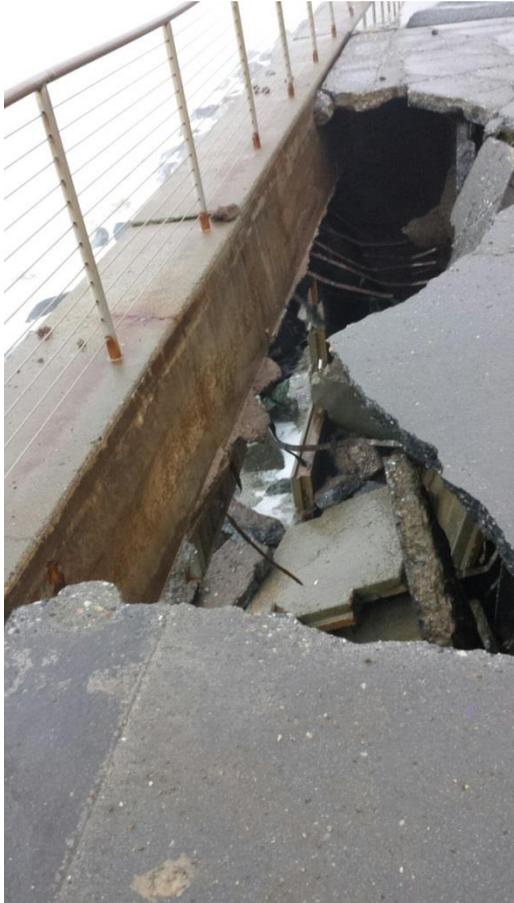
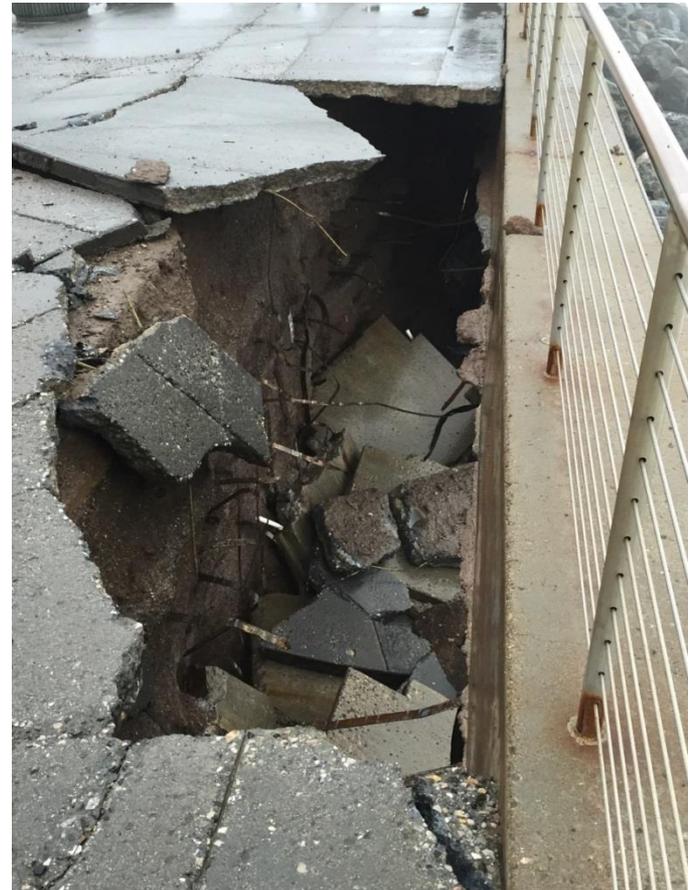
January 17, 9:00 a. m.

On January 17, 2016, DPW staff discovered a sink hole at the promenade (intersection of Beach Blvd. and Santa Maria Avenue)

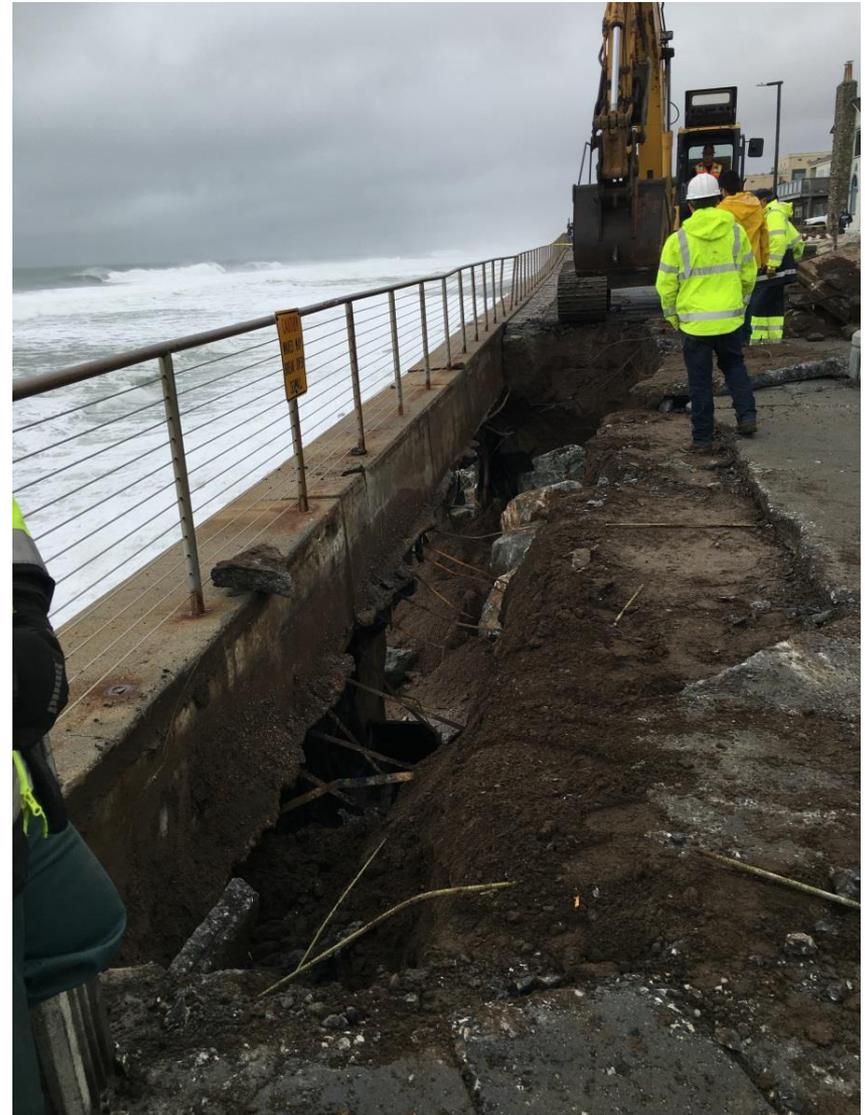
8 - 10 ton rocks being placed by DPW inside the void to protect and preserve the material underneath the promenade from further eroding due to the powerful waves

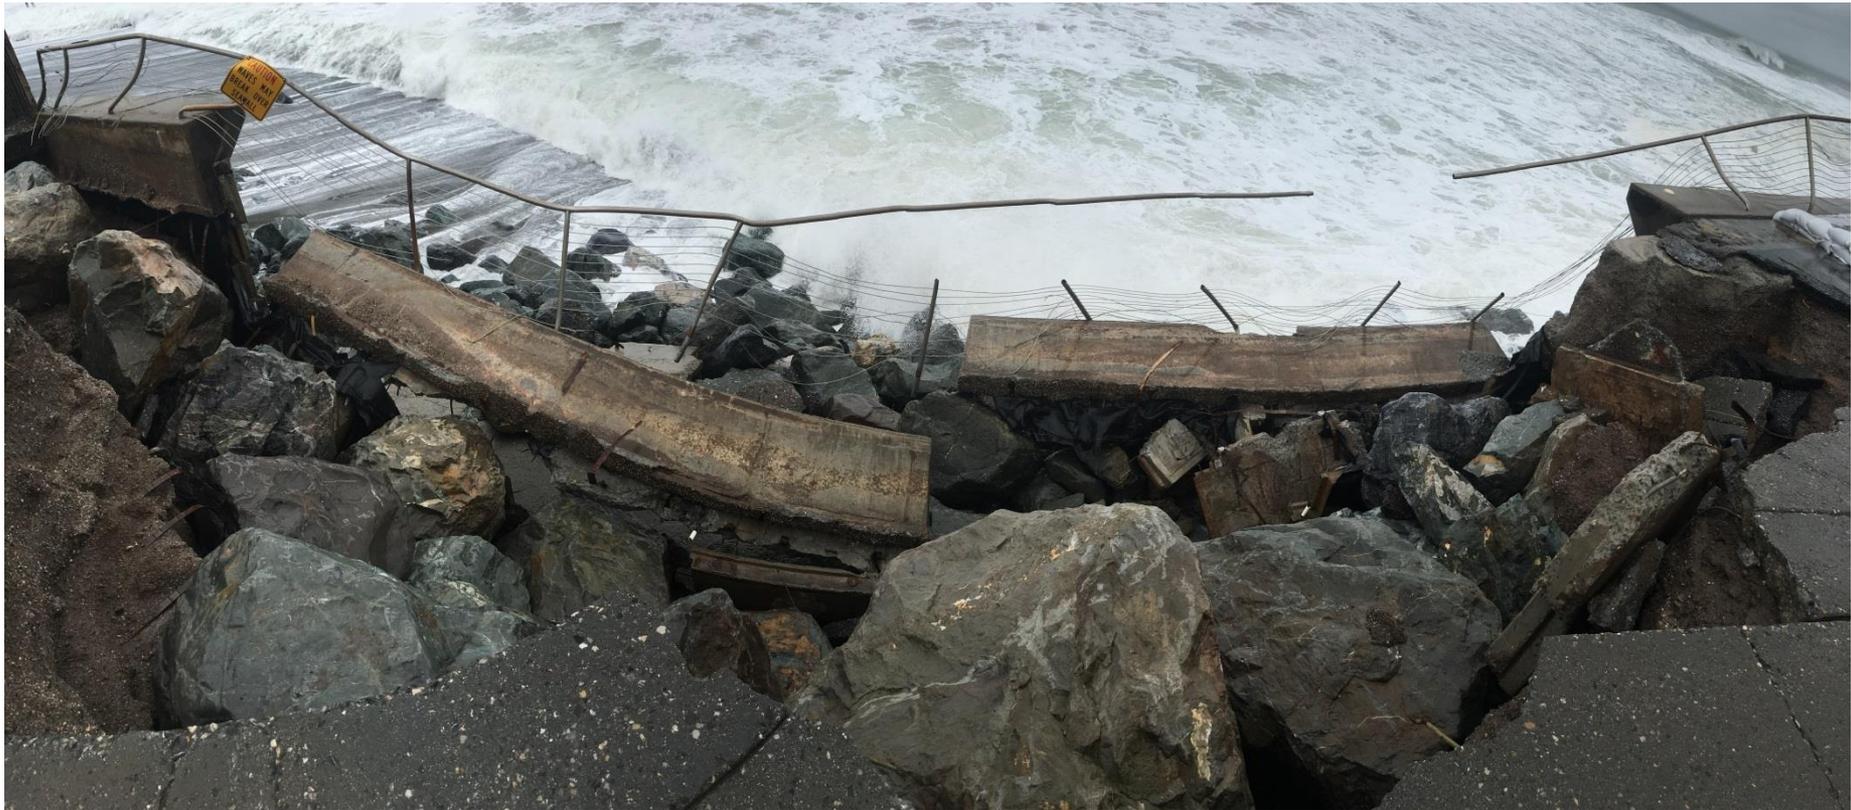
Crashing waves of January 22nd caused the collapse of the sea wall cap/wave deflector

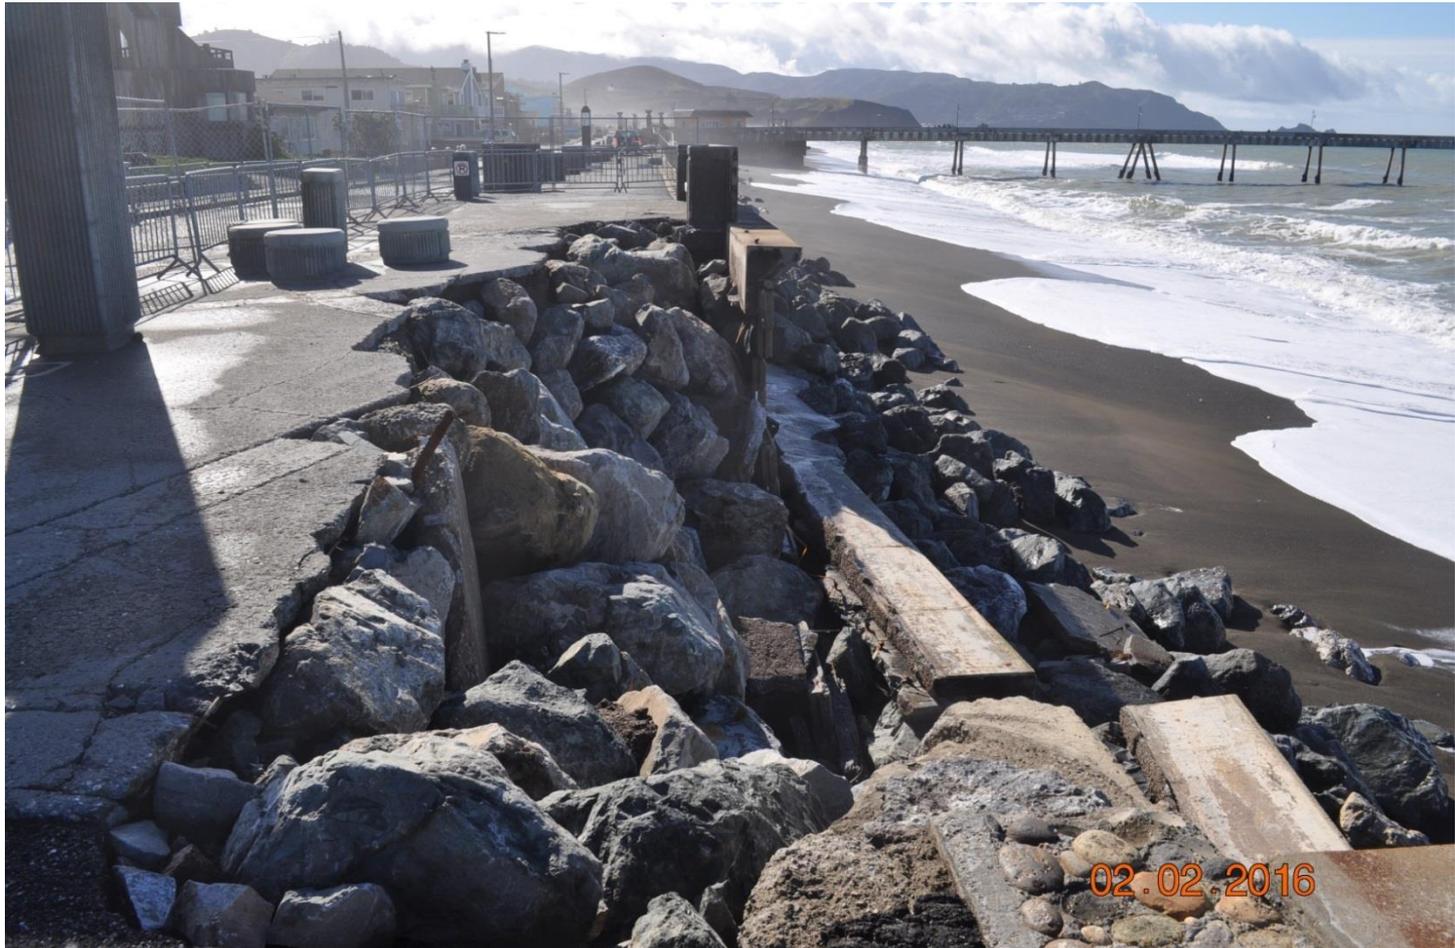
Current condition of failed sea wall section

DPW staff also added 6' high chain link fence and continue to monitor the area
