RECLAMATION PLAN

ROCKAWAY QUARRY

PACIFICA, CA

DATED: 03/19/2020

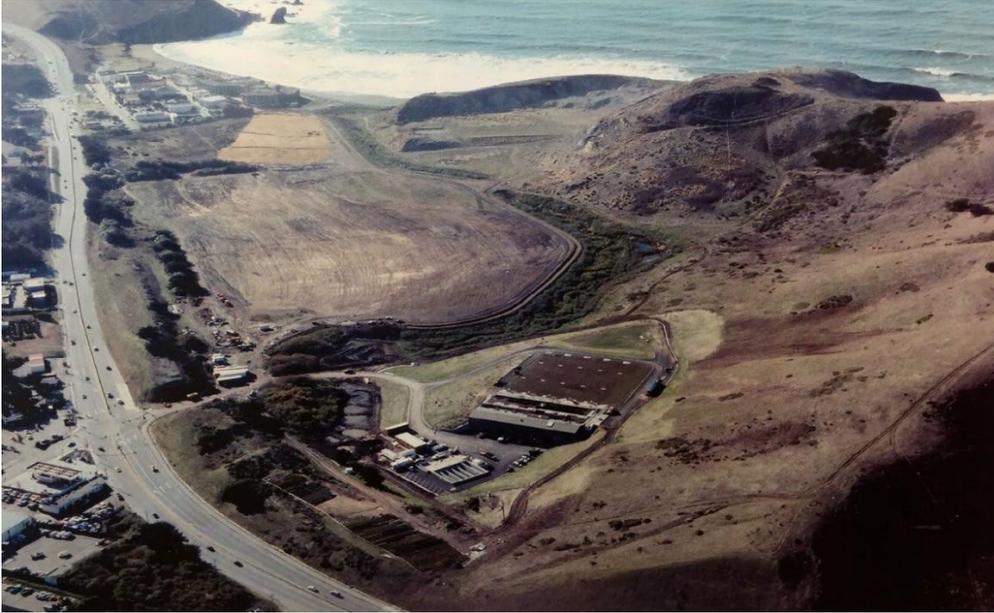
Pacifica Quarry, an oblique from the north in about 2000. The Quarry is in the right- center of the photo, just west of the newly constructed Calera Creek. The eastern parcel is in the left-center of the photo with Highway to its left (east); note its recently graded appearance and relatively level condition.

Photo 1 shows the property in 2000, shortly after the treatment plant was built and the eastern parcel graded.
